**SITE SURVEY SUMMARY SHEET  
FOR  
DERP-FUDS SITE NO. J08UT097100  
TONY GROVE CONVALESCENT CAMP  
CACHE COUNTY, UTAH**

**DEFENSE ENVIRONMENTAL RESTORATION PROGRAM  
FORMERLY USED DEFENSE SITES PROGRAM  
FINDINGS AND DETERMINATION OF ELIGIBILITY**

**TONY GROVE CONVALESCENT CAMP  
CACHE COUNTY, UTAH  
DERP-FUDS SITE NO. J08UT097100**

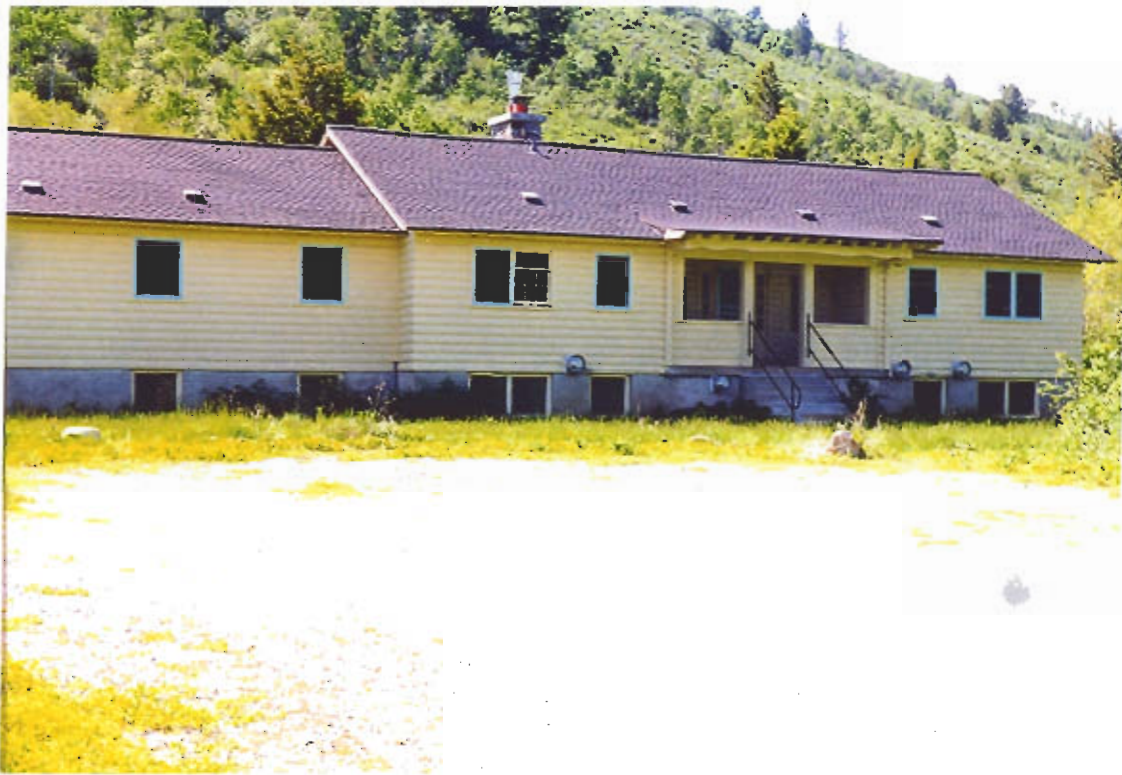
1 - View looking south at residential/classroom building at Utah State University Forestry Field Station (formerly Tony Grove Convalescent Camp).

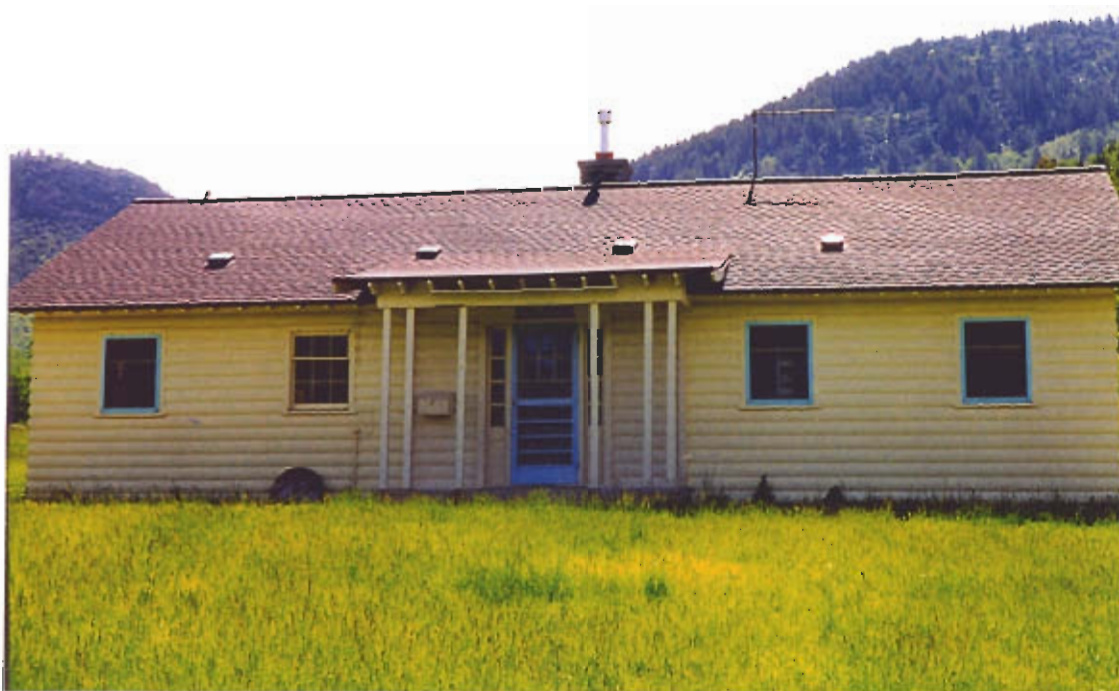
2 – View looking southeast at Raymond R. Moore Administration Building, which includes residential space.

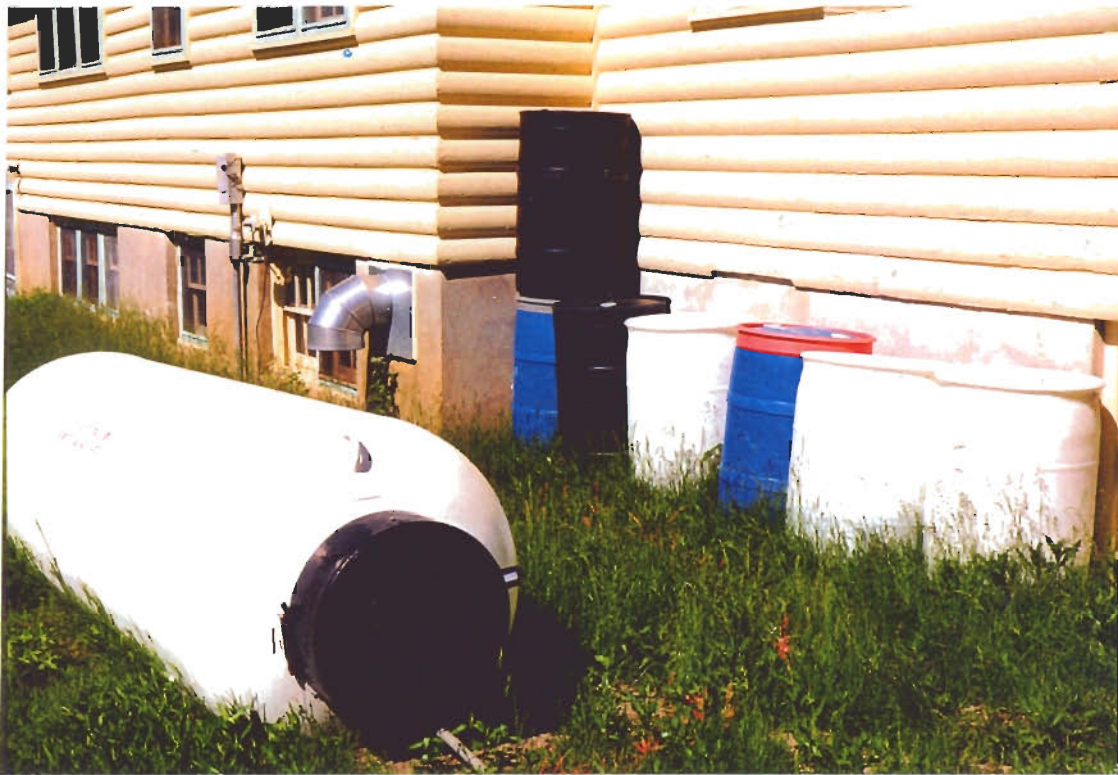
3 – View looking north at propane tank and seven plastic drums behind administration building.

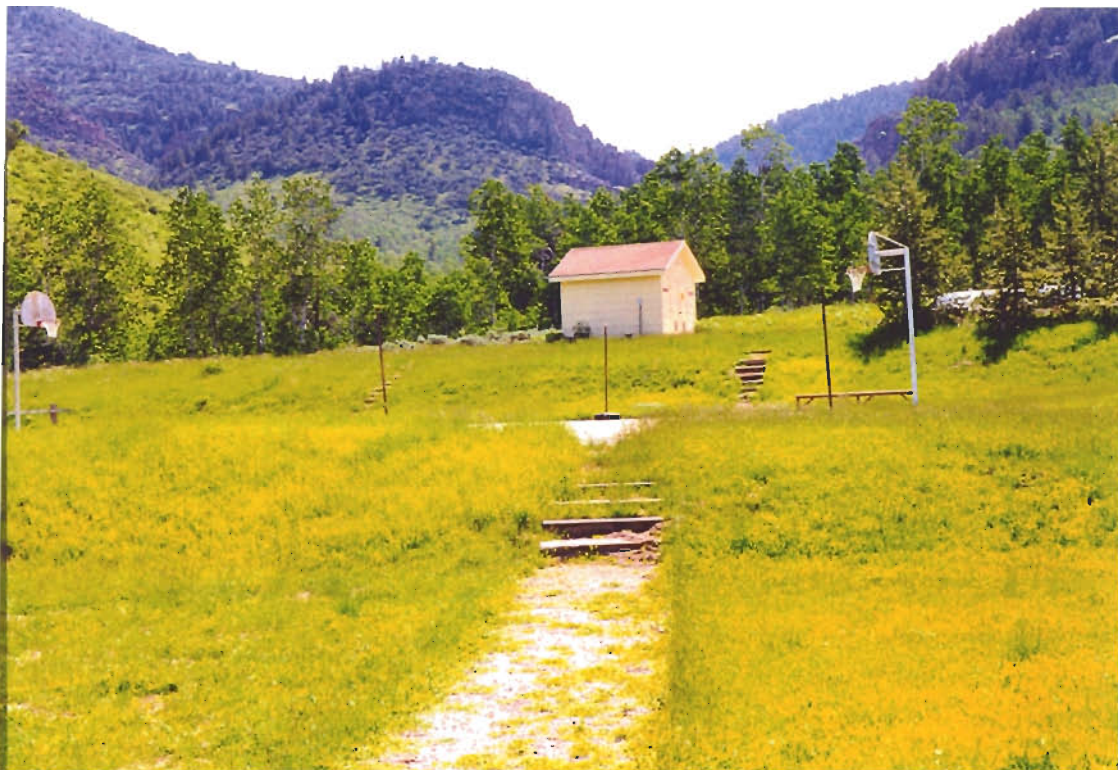
Northeast of the administration building was a recreation area containing a volleyball court and a basketball hoop. Immediately behind the recreation area and slightly up hill were a small building and several large propane tanks (Photograph No. 4). It was determined that the building contained a generator for electrical power. The propane tanks were connected in series and provided fuel for the generator. The tanks were located on a concrete slab in very poor condition. The slab contained many cracks and pieces of the concrete had heaved (Photograph Nos. 6 and 8). Along the western edge of the slab an approximately six-inch diameter floor drain was observed (Photograph No. 7). Although there is a drain line leaving the floor drain and traveling to the west, the purpose of the drain could not be determined. The project team met with Mr. Fred Houston, Supervisory Forester for the Logan Ranger District after the site visit and he was unable to provide any information regarding the drain. Mr. Houston was also asked about the concrete slab and whether there were any underground tanks on site and specifically if there was one under the slab. He stated that to the best of his knowledge there had never been any underground tanks on site (Houston 6/17/99). The project team also spoke with Mr. Clair Marler a Utah State University, Water Quality Technician who arrived at the site during the visit. Mr. Marler was also unaware of the drain and its purpose, and had no knowledge of any underground storage tanks (Marler 6/17/99).

4 – View looking southeast at small building, basketball court, and three propane tanks (behind row of pine trees).

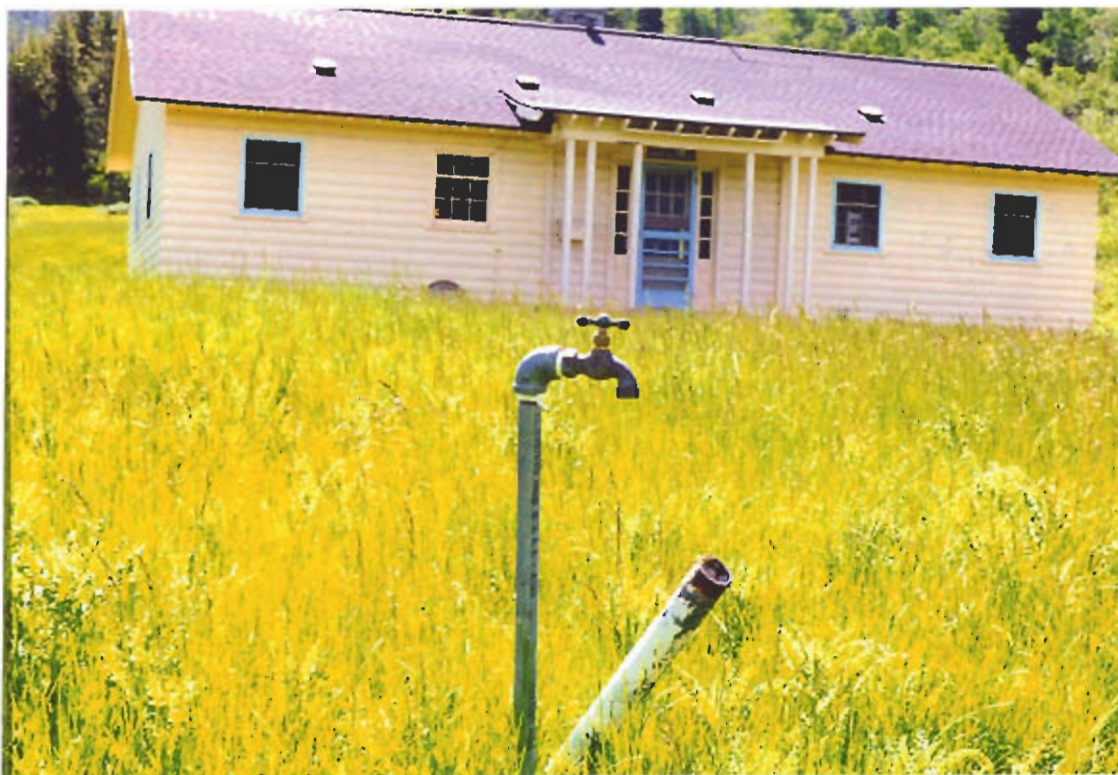
5 – View looking southeast at hose bib and two-inch galvanized pipe serving an unknown purpose.  
Note administration building in the background.

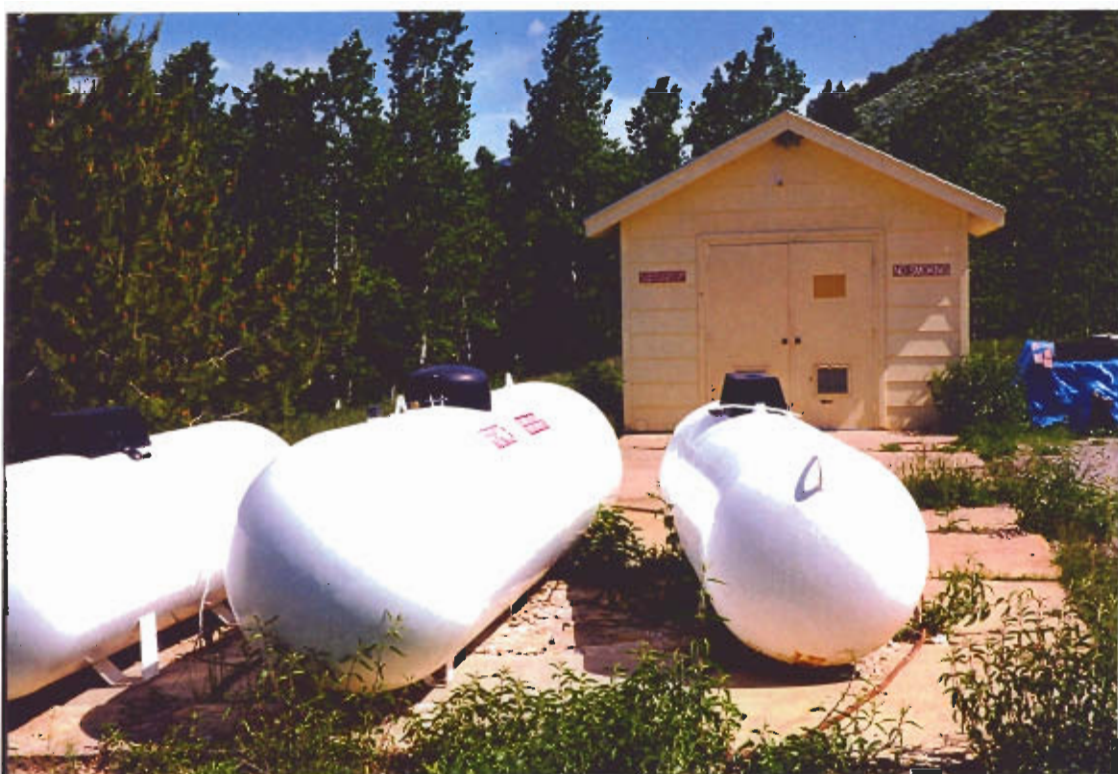
6 – View looking northeast at three propane tanks and electric generator building in the background.

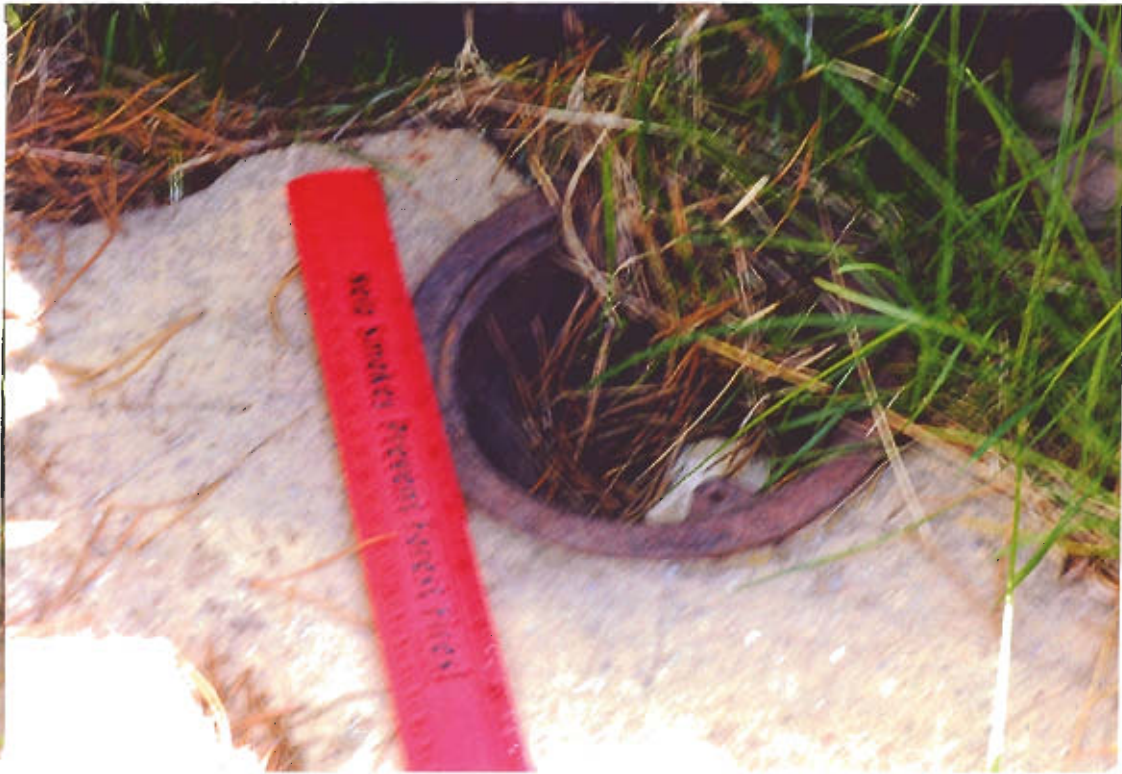
7 – View looking at open cast-iron drain or filler pipe located along western edge of the concrete pad for the propane tanks.

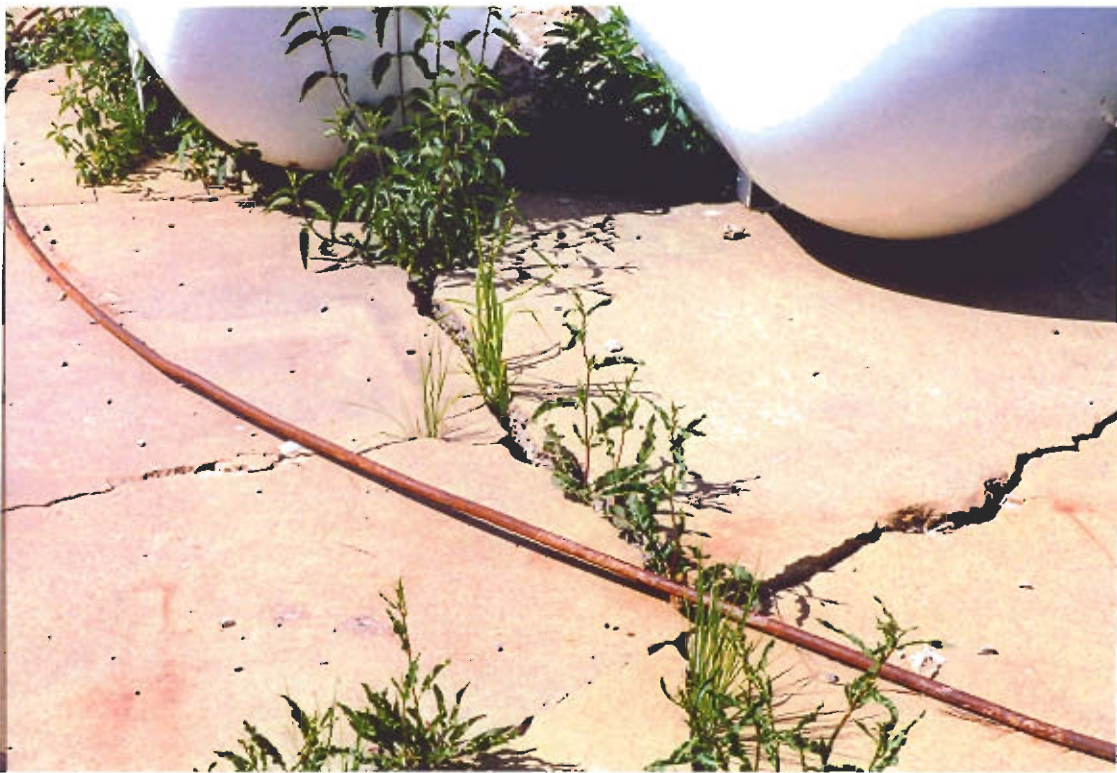
8 – View looking southwest at propane tanks and concrete pad, which is deteriorating.

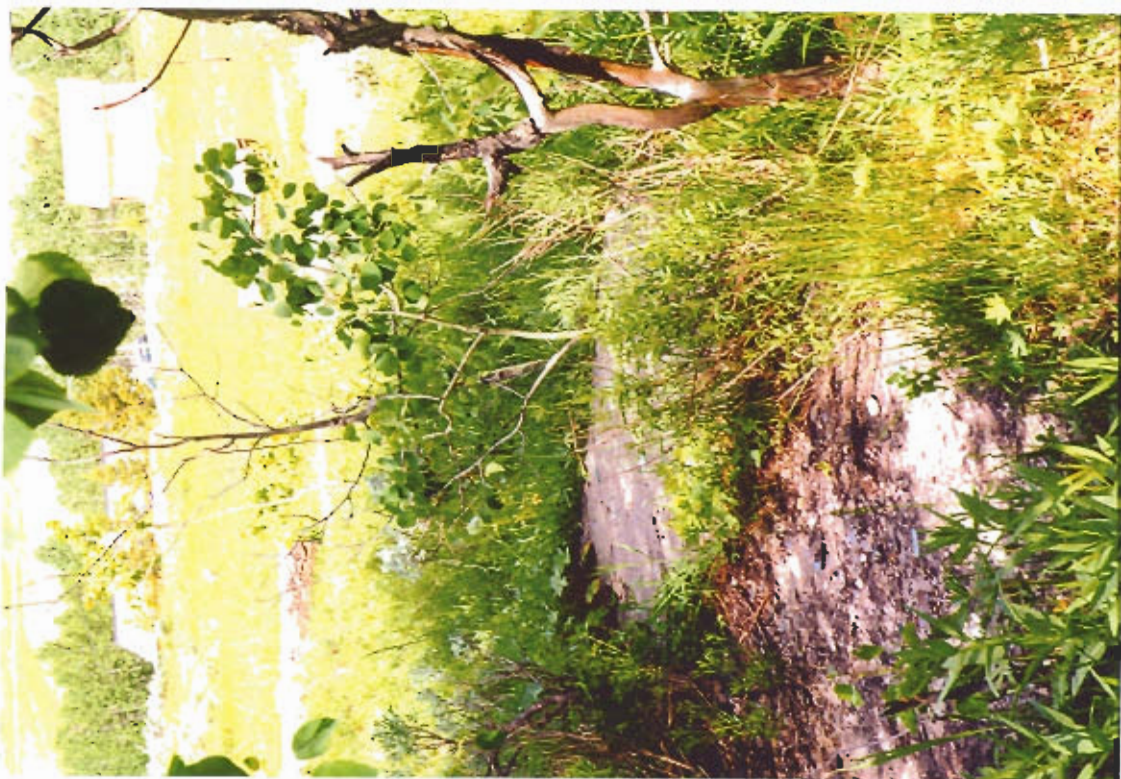
The project team observed a smaller concrete slab in the trees immediately off the north side of the dirt road, and approximately 150 feet east of the generator building. Mr. Marler was asked if he knew what the purpose of this slab was and he stated that he hadn't realized there was a slab there (Marler 6/17/99). The slab was noted to be about one to one and one-half

inches thick (Photograph No. 9). According to Mr. Houston this slab may have been used for an aboveground storage tank that may have contained diesel fuel or fuel oil. He indicated that the mess hall used fuel oil at one time (Houston 6/17/99). Mr. Houston and Mr. Marler both informed the team that there had been a fire on the site in 1998, which burned the mess hall to the ground. The mess hall was previously located to the west of the recreation area (Houston/Marler 6/17/99).

9 – View looking southwest at concrete pad measuring approximately 8 feet x 9.5 feet. Note generator building in the background.

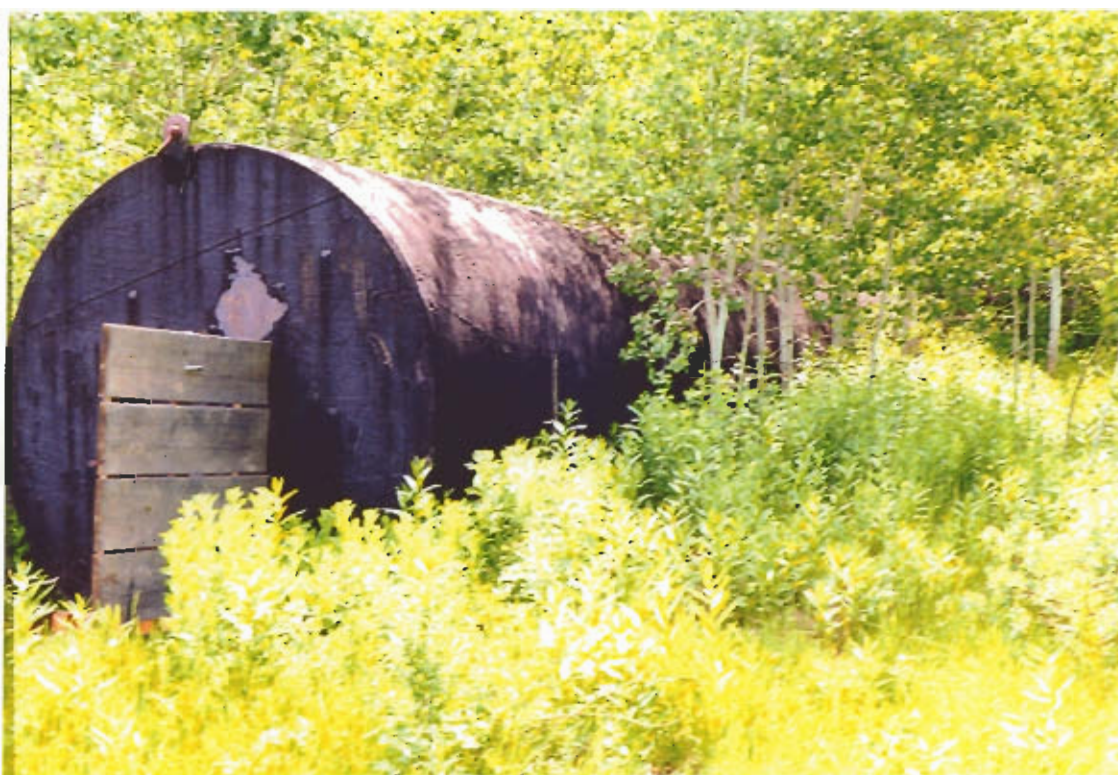
When the project team stopped to speak to Mr. Marler he was driving down a dirt road which headed east from the locked gate at the entrance to the site and up the hill into the woods. He informed the team that there was a large water tank up the hill for fire fighting purposes (Photograph No. 10). The tank was noted to be approximately eight feet in diameter by about 32 feet in length.

10 – View looking east at water supply tank and wooden valve box. Note that hasp is damaged and valve box cannot be locked.

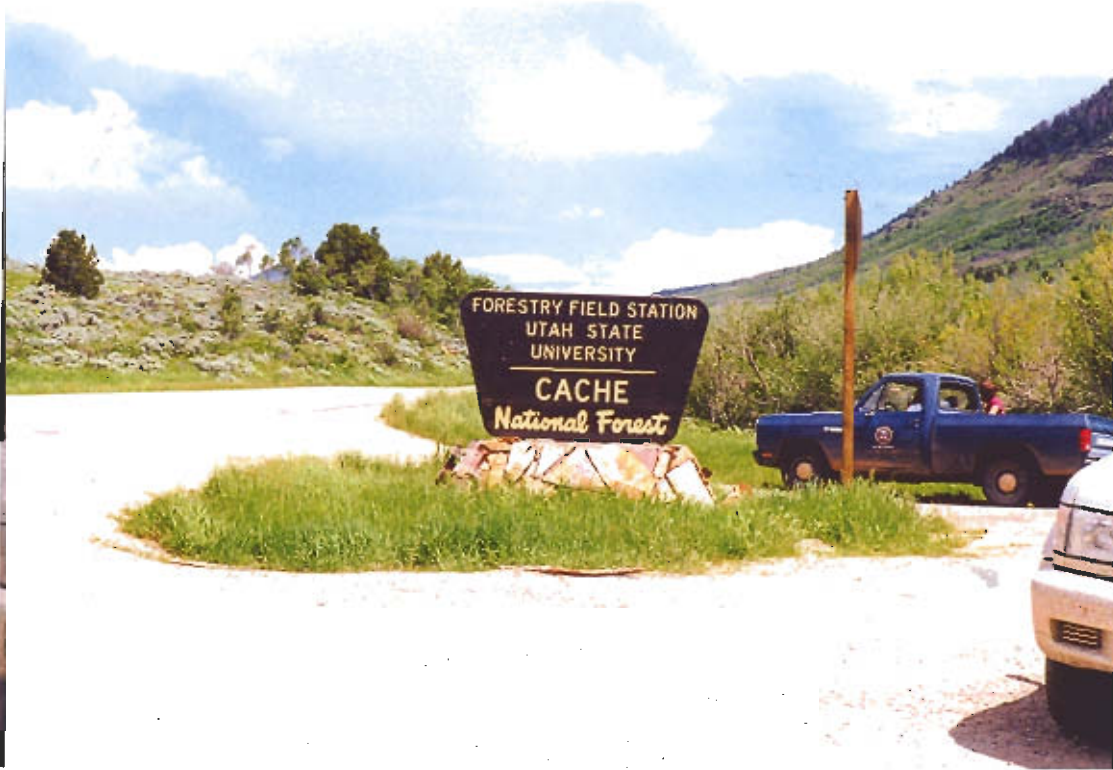
The project team left Highway 89 and drove several hundred feet up a dirt road to a locked gate barring vehicle access. The turnoff from Highway 89 is clearly marked by a sign for the Forestry Field Station (Photograph No. 11). The area just prior to the gate provided ample

11 – View looking north at Highway 89 and the entrance marker sign to the Utah State University Forestry Field Station (formerly Tony Grove Convalescent Camp during WWII).
